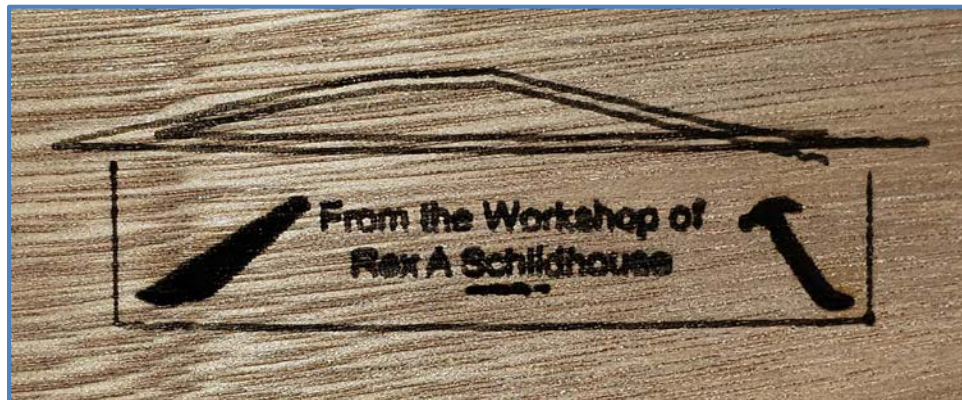
This is the 2" file - The roof is not proper or aligned, nor is it sitting on the rectangular frame. The saw and the hammer got trimmed. What happened to "2021"?

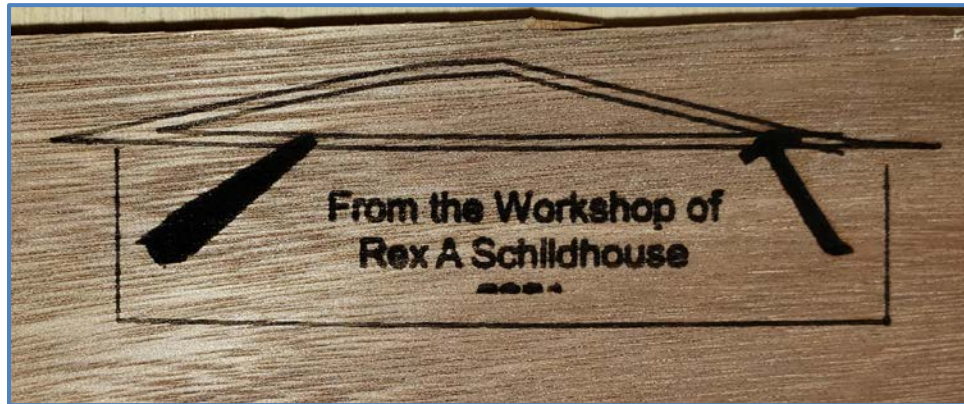
This is the 3" file, roof issues, tool placment issues, 2021 issues.

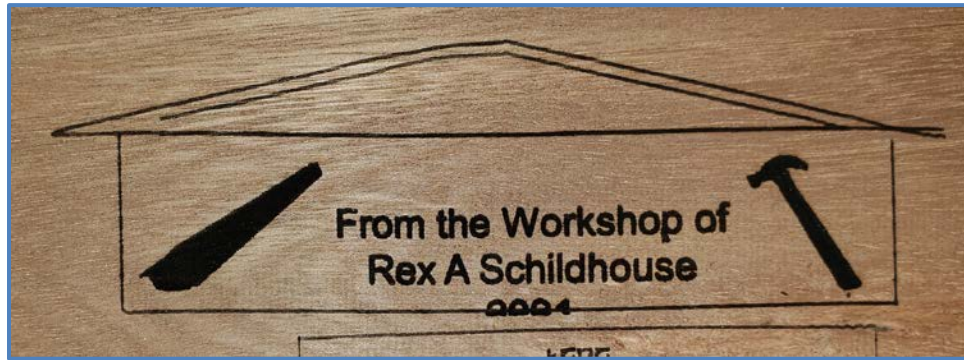
This is the 4" file, 'nuff said.
