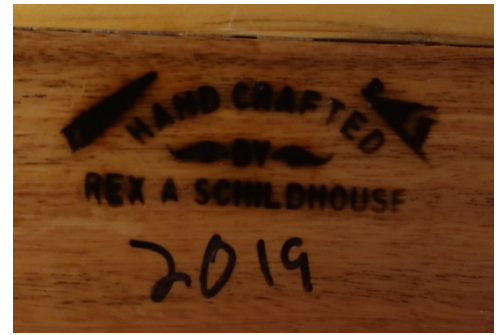
This is what I was trying to mimic. A branding iron, from Rockler, that just takes **TOO** long to heat up consuming **TOO** much power. Technology gives us lasers so I bought the Ortur and Lightburn. Poor photo, sorry.

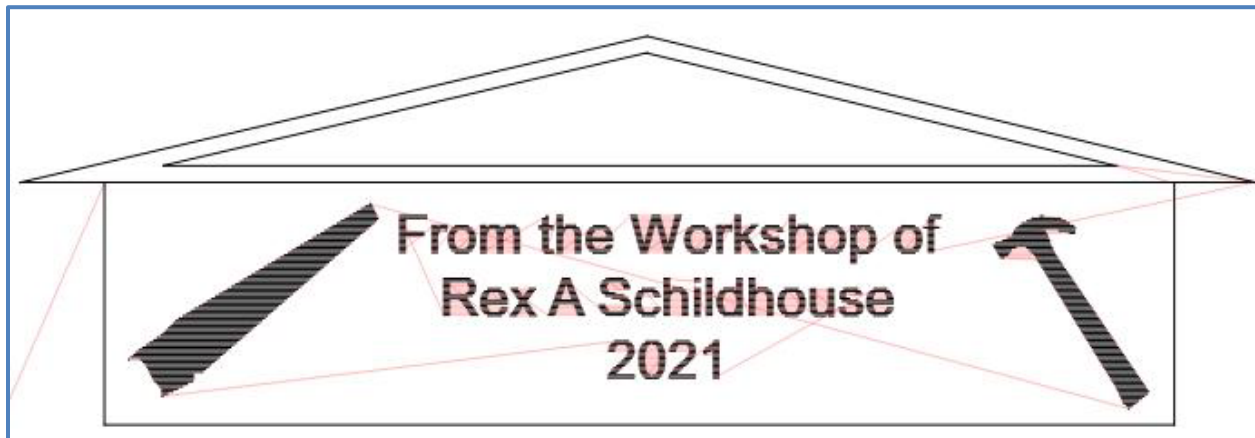
This is the Lightburn preview image.

This is the 2" file - The roof is not proper or aligned, nor is it sitting on the rectangular frame. The saw and the hammer got trimmed. What happened to "2021"?

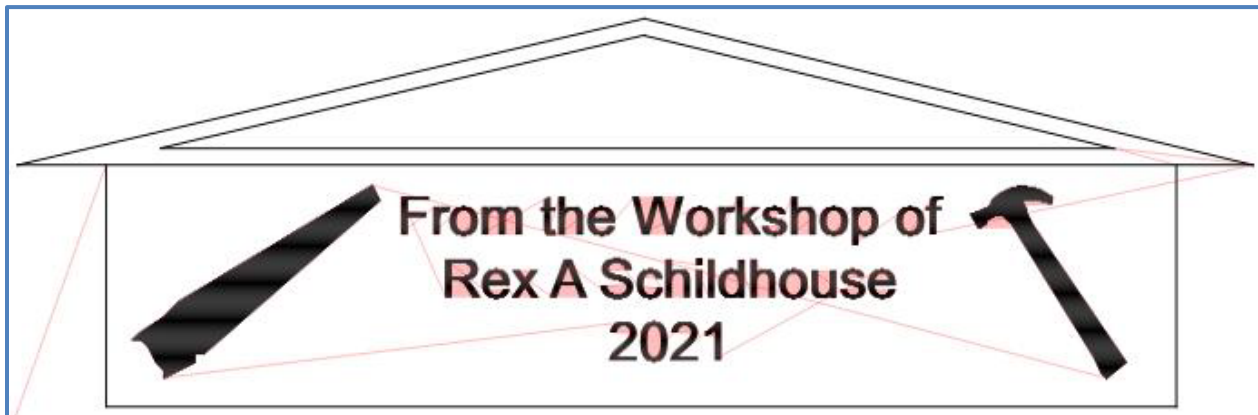
This is the Lightburn preview of the 3" burn.

This is the 3" file, roof issues, tool placment issues, 2021 issues.

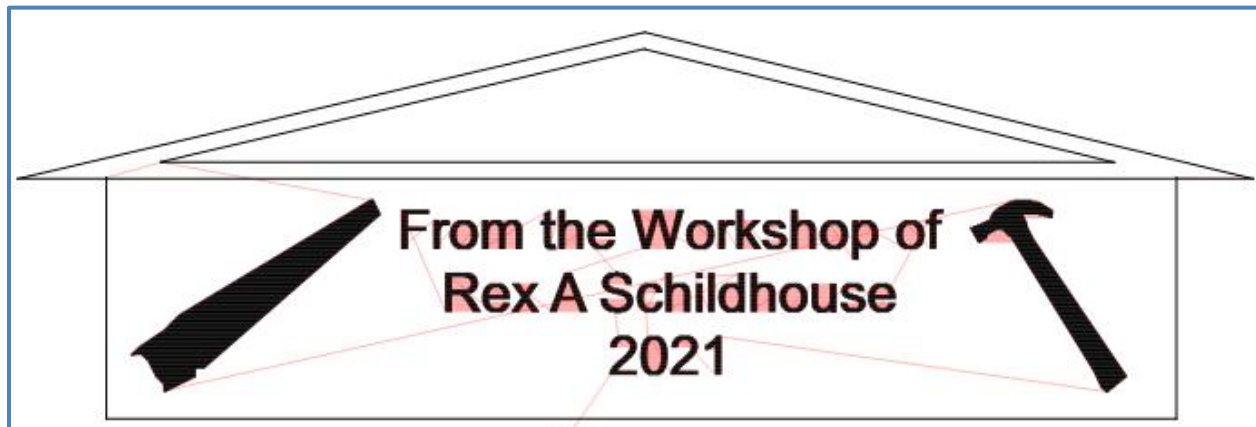
This is the 4" file, 'nuff said.
